**Using Aerial Imagery over Cheyenne Bottoms Wildlife Area
to Map the Extent of High Water Levels.**

Michael E. Houts
GIS/Remote Sensing Specialist
Kansas Department of Wildlife and Parks
Kansas Applied Remote Sensing Program
Kansas Biological Survey

July 25, 2007

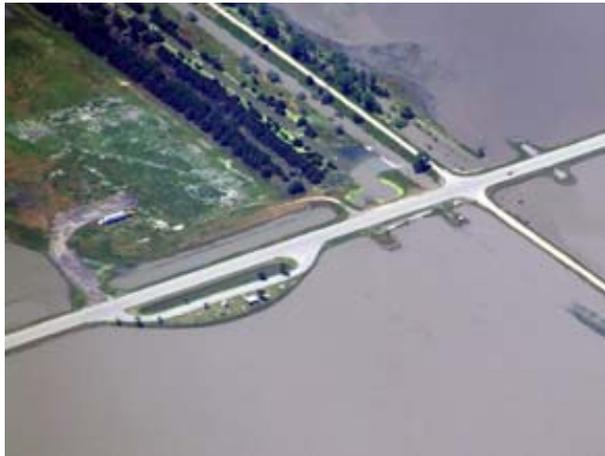
Figure 2. A view looking south across the rest area/overlook on highway 156. The road is about 20 feet above surrounding CBWA ground levels and water would not normally be visible anywhere in this view.

Data acquisition took place between 11:30 and 1:15 pm with clear skies dominating the horizon, during which time 443 pictures were acquired. A personal hand-held digital camera was used to acquire additional pictures out the plane window of the high-water conditions. These pictures ranged from zoomed in on specific locations to wide-angle images that attempted to show a large area (Figure 2, 3, 4).

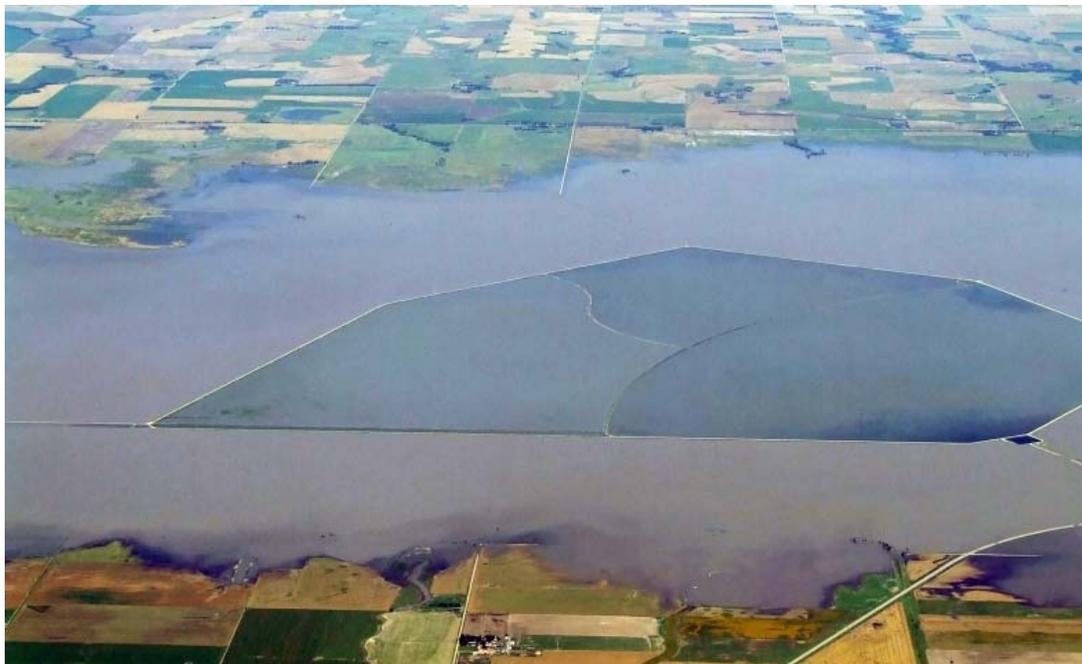
Figure 4. Image looking north with highway 156 cutting across the lower left corner. The areas outside the irregular circle in the middle (water holding pools) are usually dry, as are significant portions within the pools themselves in recent years.
