Conversion of existing farm ponds to wetlands in agricultural landscapes for mitigation, land use treatment and conservation with a perspective toward climate change.

Kansas Biological Survey Report No. 189

June 2017

**For
Kansas Water Office**

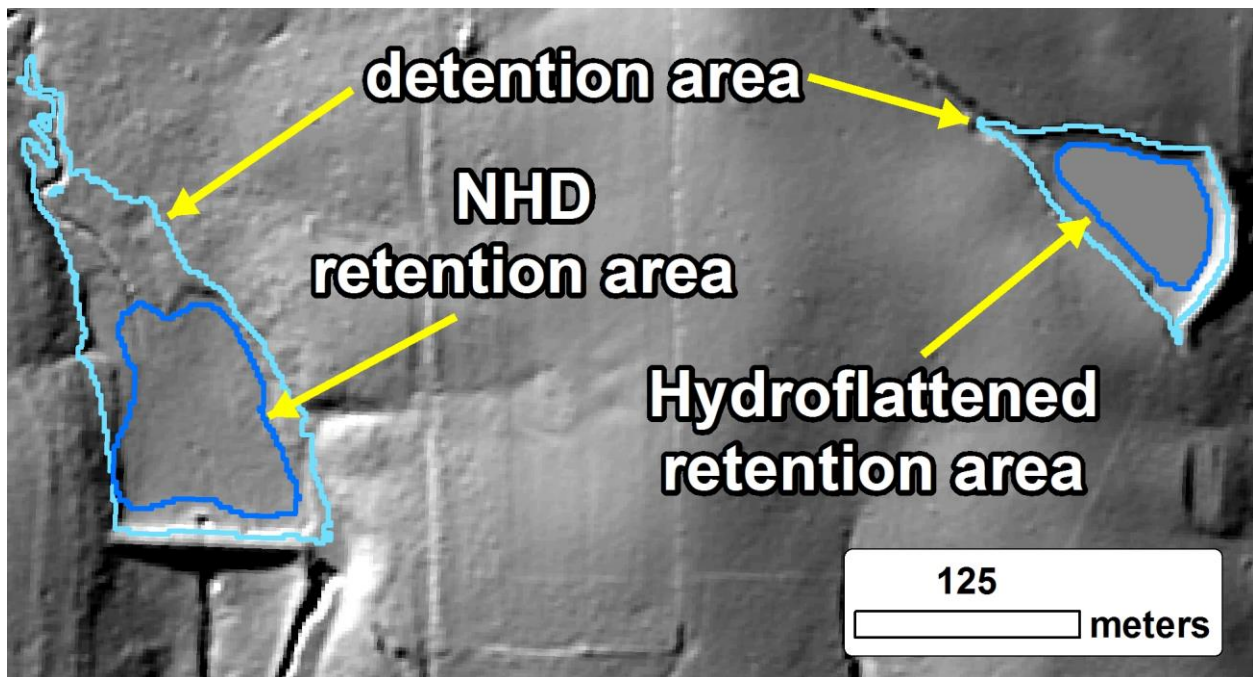
Figure 1. Retention area and detention area boundaries are shown for two elements of the initial population (POPO) of farm ponds 1-5 acres in size (See Appendix B for methods).

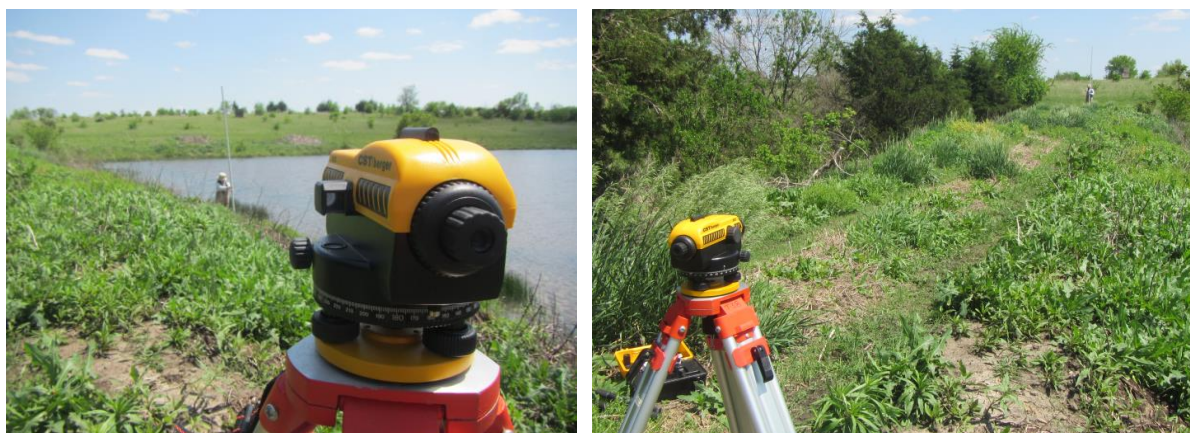
Figure 5. Standing on top of the dam at pond 257 to measure stand pipe height (left) and dam high point (right) relative to water level.

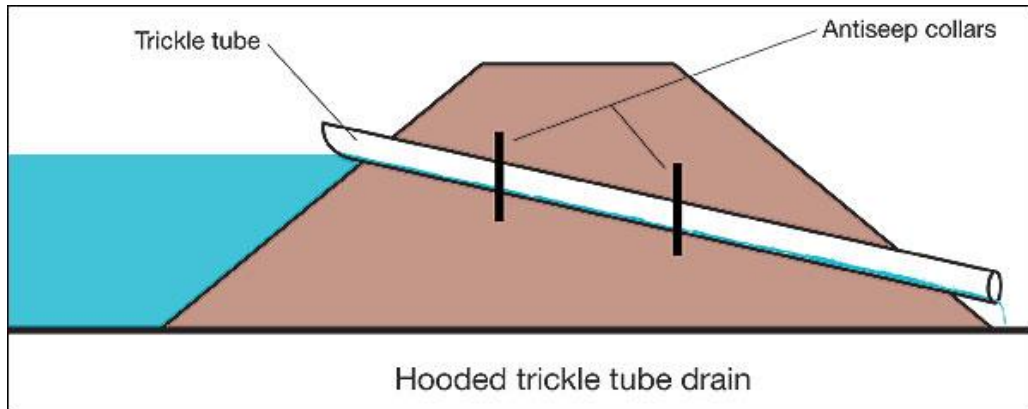
Figure 6. The hooded trickle tube drains and removes excess water from a pond during periods of normal runoff (Hicks and Pierce 2014).

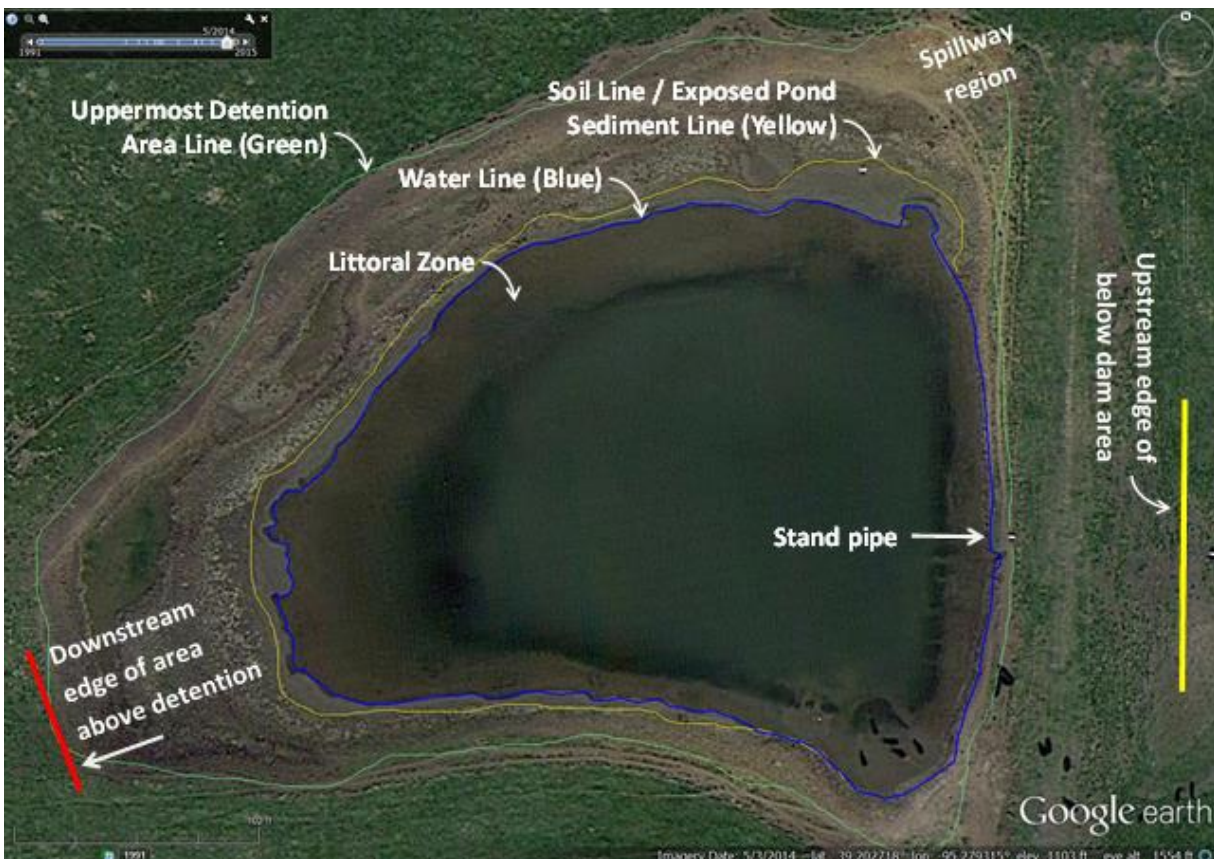
Figure 7. Schematic of two of the three pond complex zones recognized and studied in this project. The pond environment is defined by the yellow line that denotes retention area created by the stand pipe discharge point while the innermost blue line is the actual water shoreline at date of photo. The outer green line delineates the maximum flood fill thus defining the detention zone as the area between the yellow and green lines. Additionally, the yellow linear line is the 40 m width of the below dam plot, red linear line is the 20 m width of the above pond plot. This 2015 pond photograph is of a non-study pond in the Delaware River basin.

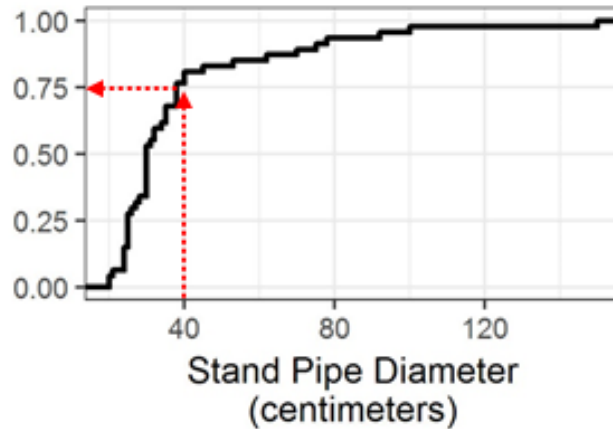
Figure 8. Empirical cumulative distribution function of stand pipe diameter for the farm ponds examined in this study, illustrating that the proportion of the population with a stand pipe diameter of at least 40 cm is 0.75.

Empirical CDFs provide a quick but informative way to characterize a group of observations. For example, Figure 8 below shows the empirical CDF for the stand pipe diameter of the farm ponds sampled in this study. Note that in this figure, the proportion of the population with a stand pipe diameter of at least 40 cm is 0.75. In other words, 75% of the farm ponds observed had stand pipes that were 40 cm or less in diameter. Moreover, this also means that 25% of the farm ponds observed had stand pipes that were larger in diameter than 40 cm.

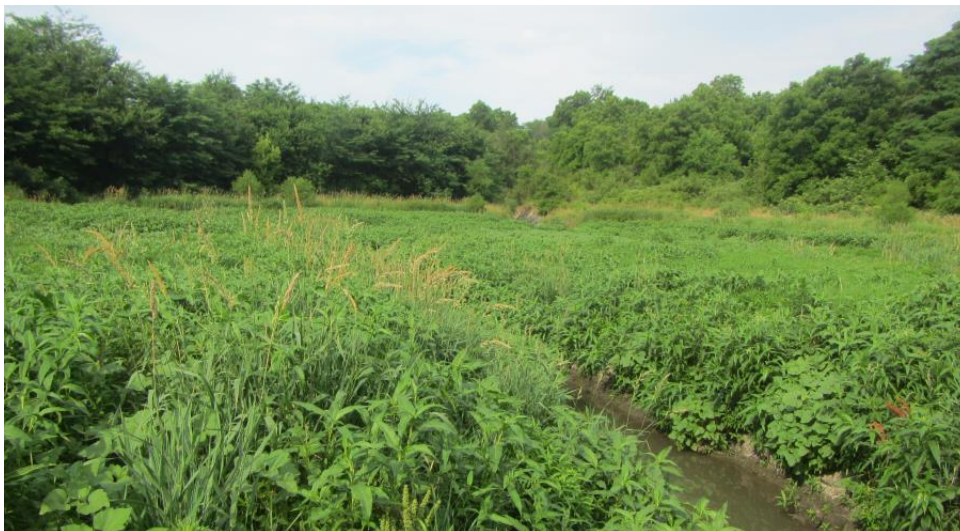
Figure 9. Breached dam allows pond 212 to begin the transition to an emergent palustrine wetland.

Of the 98 ponds visited, 96 had water. The two that were dry had intentionally breached dams (Figure 9). Further statistics and discussion are about the 96 ponds with water.

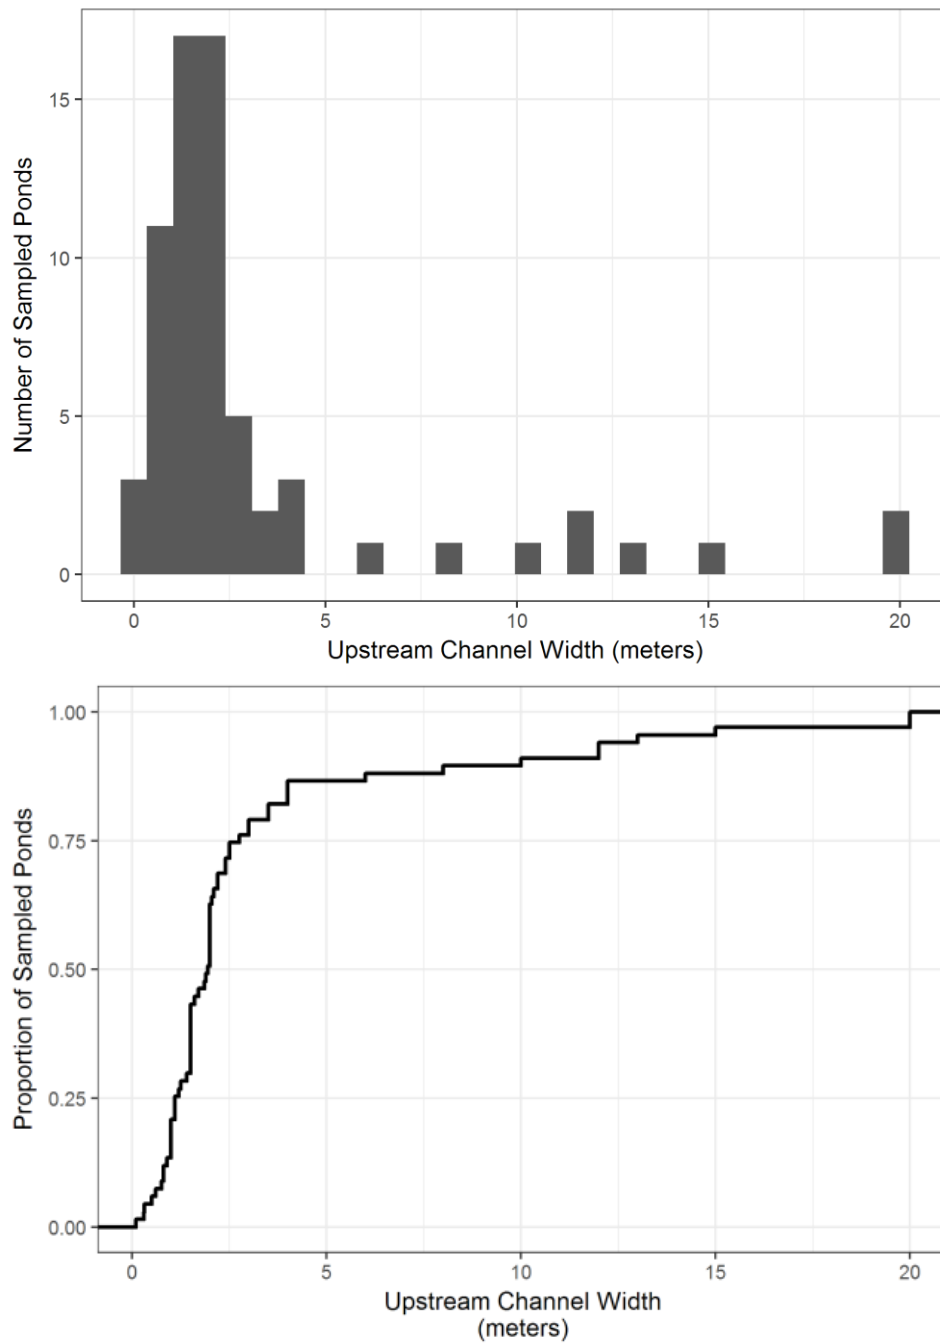
Figure 10. Histogram and CDF of upstream channel width showing that most upstream channels are < 5 m wide.

The majority of ponds (72%) had inflow channels, of which most were in stable condition (90%). When inflow channels were present they were typically less than 5 meters in width (i.e. bank full width) and somewhat shallow (<0.8 m) (Figure 10 and Figure 11). The presence of inlet channels suggests that sediment and contaminate transport to these ponds is enhanced by open channel flows as opposed to sheet, rill, and non-channel overland flows (e.g. Prosser *et al.* 1995, Meritt *et al.* 2003, Aksoy and Kavvas 2005). The predominant sediment transportation mechanism is often drainage or watershed scale dependent with sediment yield (area-specific yield) in watersheds smaller than 0.05 km² coming mainly from rill and inter-rill flows (DeVente and Poesen 2005). The majority of pond watersheds in this study were greater than 0.168km² or 74.6 acres in size (the 25th percentile) suggesting gully erosion as the dominate source of sediment (yield). Many other factors contribute to both erosion and sediment transportation, but the occurrences of these large upland channels suggest that these ponds receive considerable amounts of sediment from both overland flows and the channels themselves. Smith and Wilcock (2015) observed that study ponds with inlet channels were also experiencing head cutting, which was also determined to be another source of pond sediment. Of the 7 inflow channels showing signs of unstable channel conditions, all but one showed evidence of livestock use in the plot. Conversely, over a one-third (34%) of all stable inflow channels assessed were noted to have past or present livestock use in the plot.

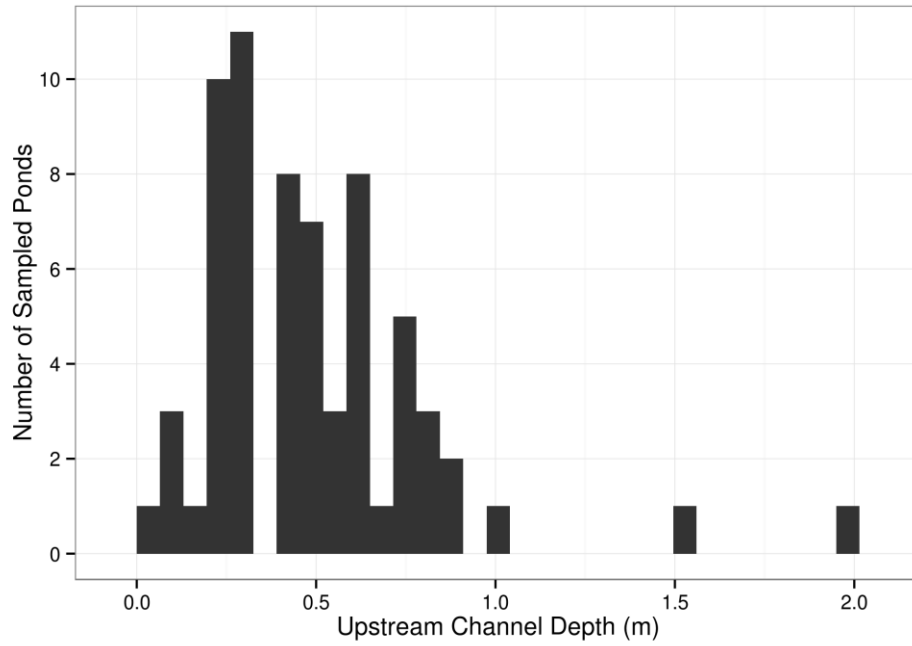
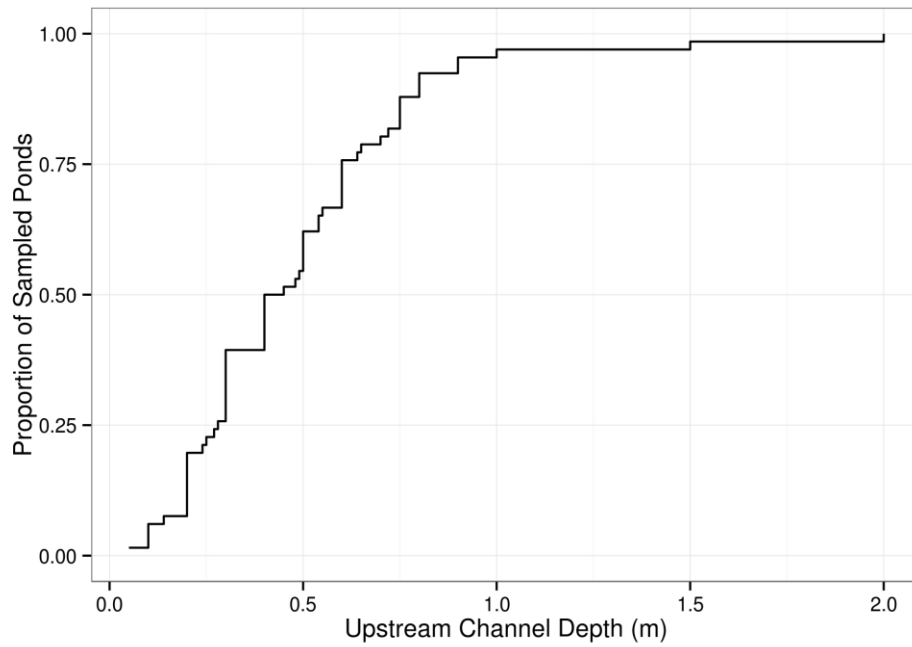
Figure 11. Histogram and CDF of upstream channel depth showing that most upstream channels are < 0.8 m deep.

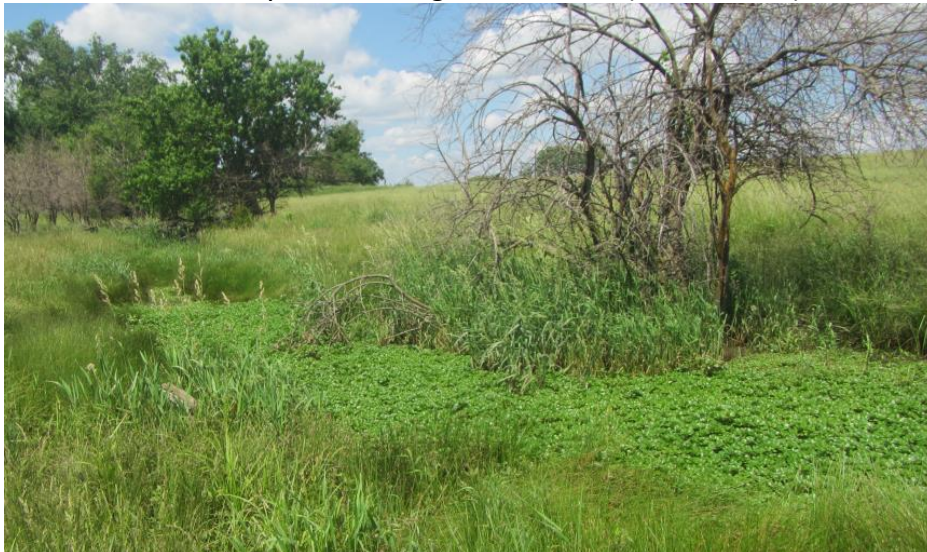
Figure 12. The channel of the upstream inflow area of pond 145. Vegetation was categorized as 35% wetland plants, 5% woody, 70% grasses and annuals, 0% crop, and 5% bare soil. A channel was present and measured 2 m wide and 0.75 m deep, and deemed stable.

Typical, dominant vegetation in these inflow areas was grassy ground cover and an overstory of woody vegetation (i.e. trees and shrubs, Figure 12). Few inflow areas had crop cover (8%), and those that did had 20% or less of the area in crop. Nearly all inlet areas surveyed had some grass and annual cover with some sample sites having 100% of their area in grasses with over half (55%) of these areas being dominated by grasses and annuals (> 50% cover). A very high percentage of inflow sample areas (76%) had some sort of wetland vegetation cover with about 14% of these areas dominated by wetland vegetation cover (> 50% cover).

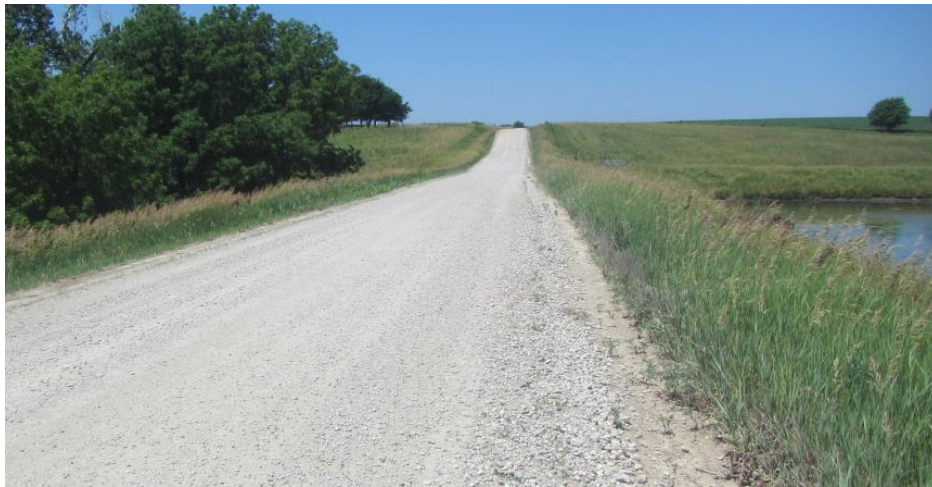
Figure 13. Few dams also function as a road such as pond 172 (high point elevation 2.505 m above water level, 0.635 above spillway low point).

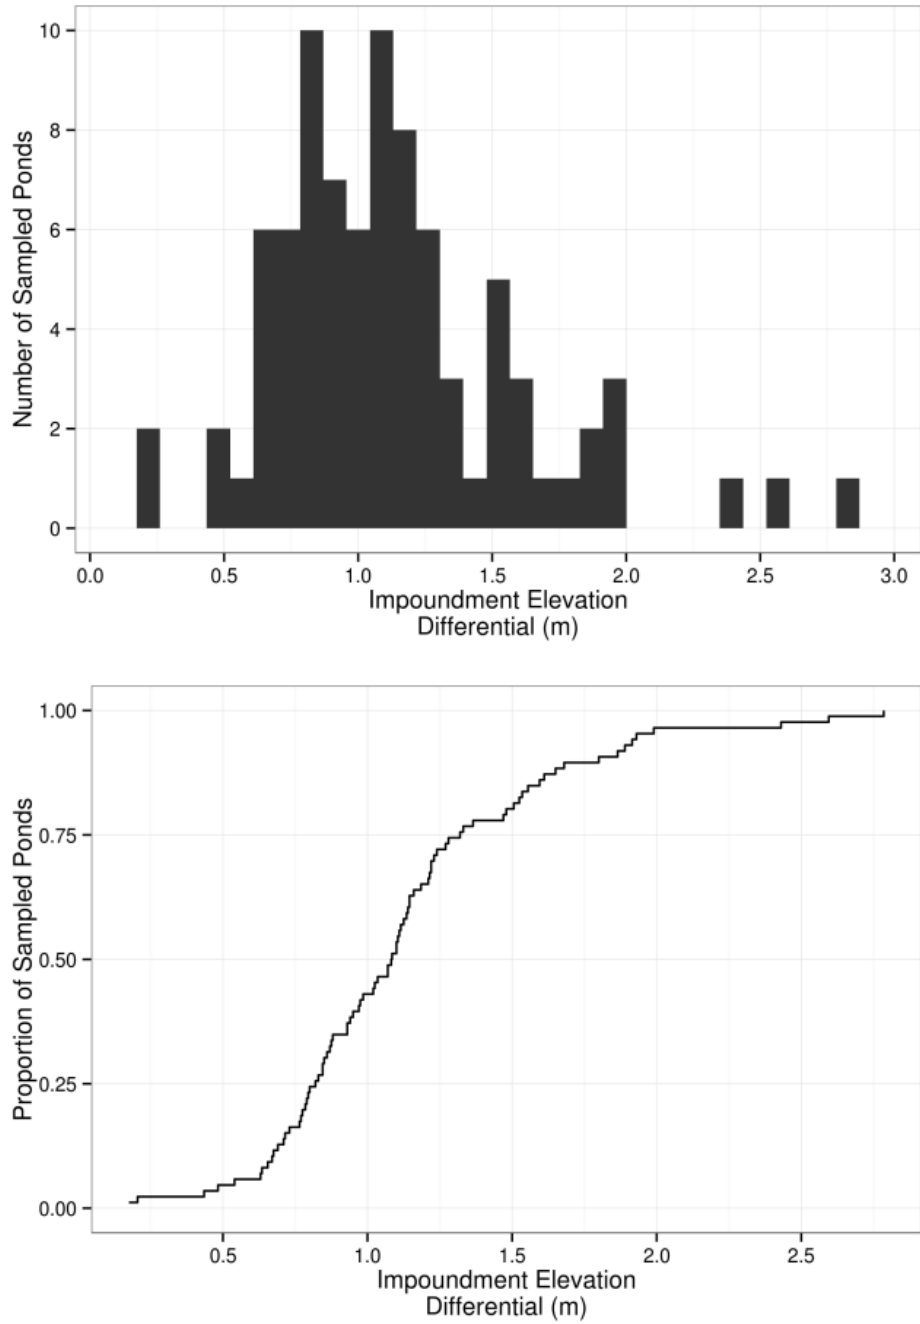
Figure 14. Histogram and CDF of the elevational differences (m) between the spillway low point and dam high point.

Elevational differences between these high and low LiDAR-determined points ranged from 0.175 to 2.785 m with the minimal elevation difference of 0.175 m representing the one pond configuration that did not have a spillway. That pond's dam and several others constituted a private road where the lowest elevation of the road serves as the emergency spillway or overflow area (Figure 13). Over 75% of all elevational differences between the spillway crest (i.e. LiDAR low point) and the dam high point were less than 1.5 m (Figure 14). As mentioned, two dams had breaches that were sufficient to drain their ponds, while an additional four ponds (136, 186, 221, 277) had shallow breaches that did not interfere with the pond's normal water retention capabilities (i.e. water level with bottom of trickle tube). Ponds 268 and 277 were Kansas Watershed District structures (Jean and Sanderson 2015, Figure 15). These two Kansas Water District dams are part of the approximately 1,539 PL 83-566 and other public funded dams that normally follow earth dam planning and design procedures outline by NRCS in a number of technical publications (e.g. NRCS 2005).

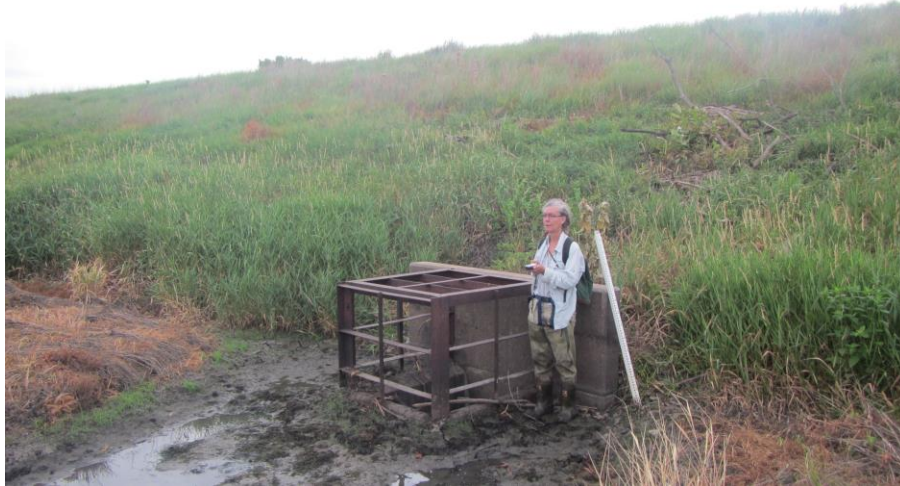
Figure 15. Standing at the pond-side base of a large dam (high point elevation 6.2 m above water level, 1.99 m above spillway low point) which is the watershed dam of pond 268.

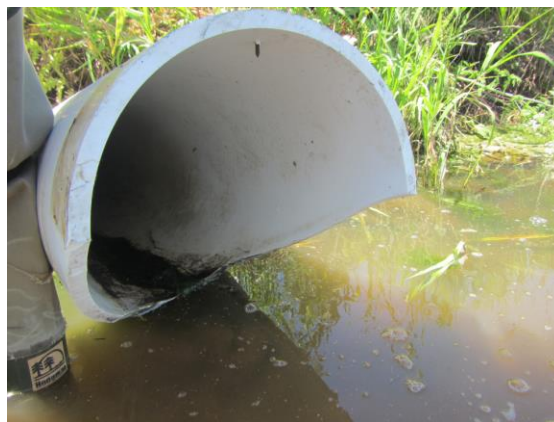
Figure 16. A beveled cut in the stand pipe opening may have been the landowner's attempt to reduce debris buildup on stand pipe at pond 279. The opening of the 30 cm diameter pipe was 2 mm above the surface of the water.

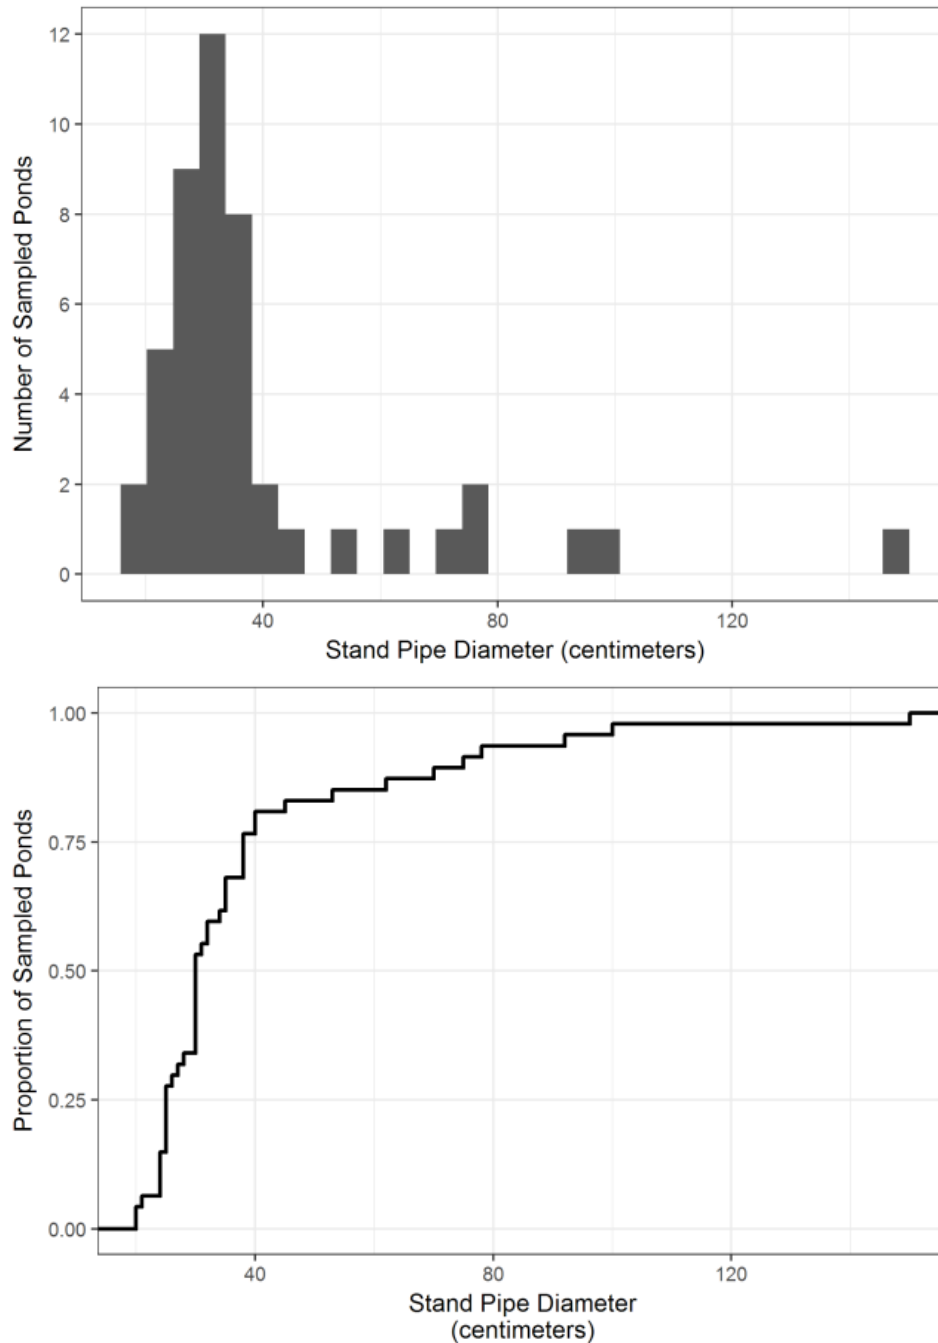
Figure 17. Histogram and CDF of stand pipe diameters (cm).

Pipe diameter measurements were not part of the original sampling regime but were added later so that only 47 ponds were assessed for this parameter. The diameter of trickle tubes and pipes ranged from 20 to 150 cm (8 to 60 in.) with the majority of diameters less than 40 cm (\approx 16 in, Figure 17).

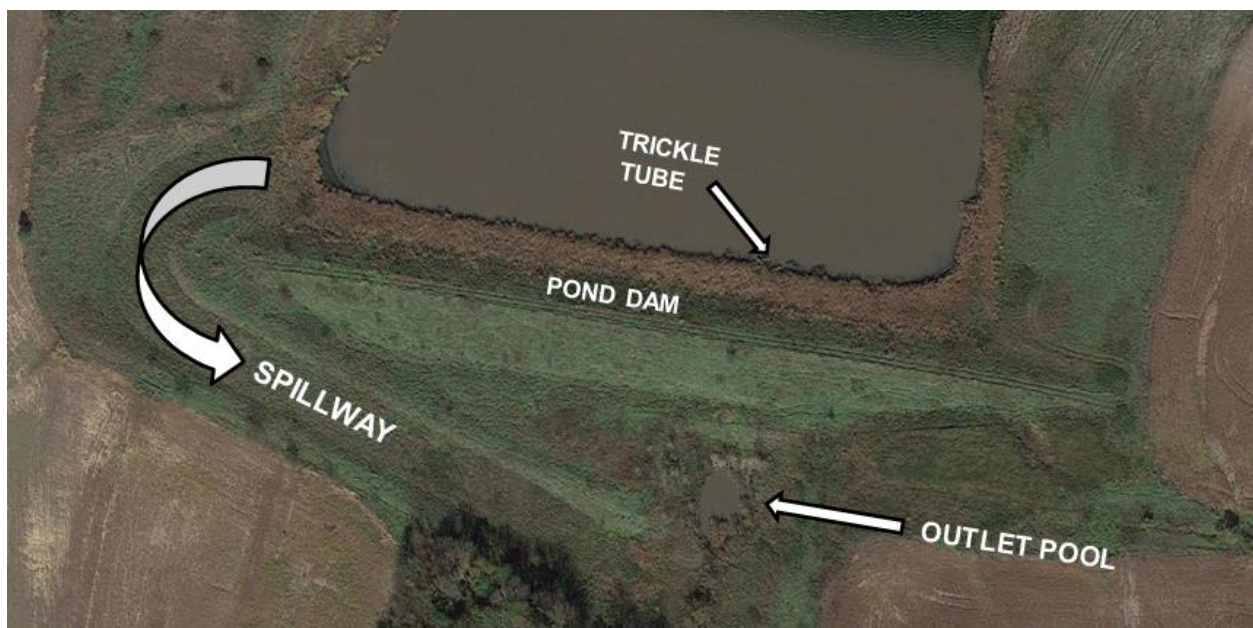
Figure 18. Delaware River Basin farm pond showing spillway system, pond dam, and outlet structures.

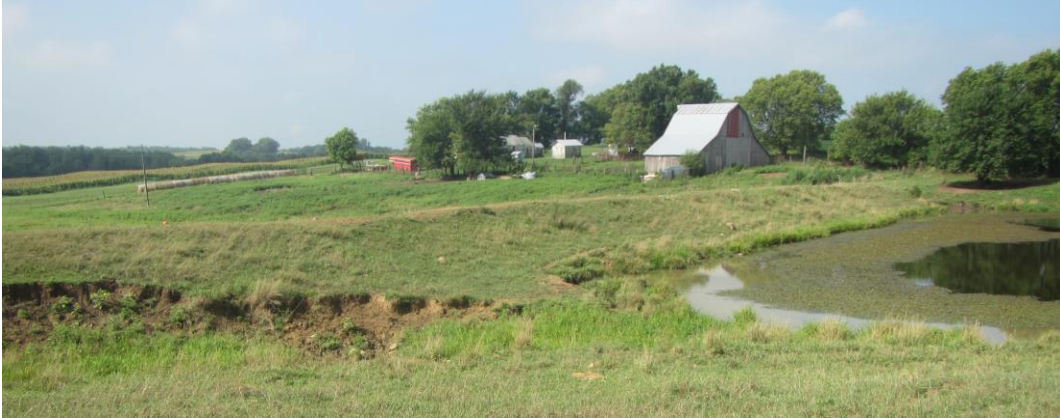
Figure 19. At pond 262, the eroded spillway is seen in the left foreground.

All but one of the spillways assessed were placed in grass/rocked category, and eventually all those assigned this category were noted to have only grass cover and no rocked spillways were observed (Figure 18). The single spillway coverage not assigned the grass/rocked category was identified as a bare soil spillway condition. This particular spillway was in fact mostly bare soil because of extensive cattle trailing and use but did retain some vegetated areas. No signs of erosion were noted on this bare soil spillway, but about 6% of the spillways surveyed did show some limited signs of erosion with most of the erosion occurring in limited areas along the course of the spillway length (Figure 19Figure 18).

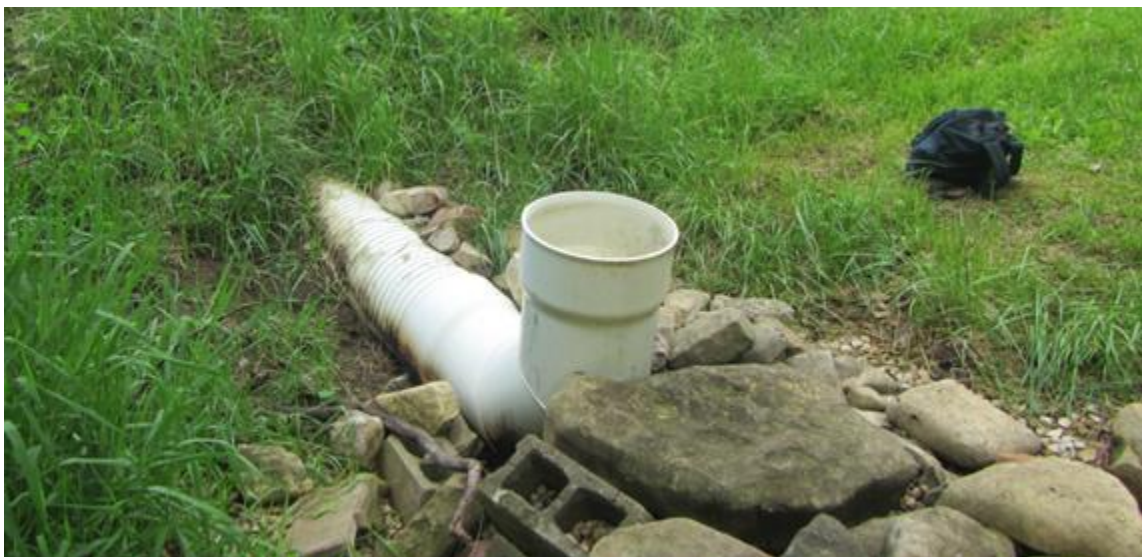
Figure 20. Pond 183 standpipe, the underside of which is cracked allowing water to pass. Also note the lack of a trash guard that would reduce debris from plugging the outlet.

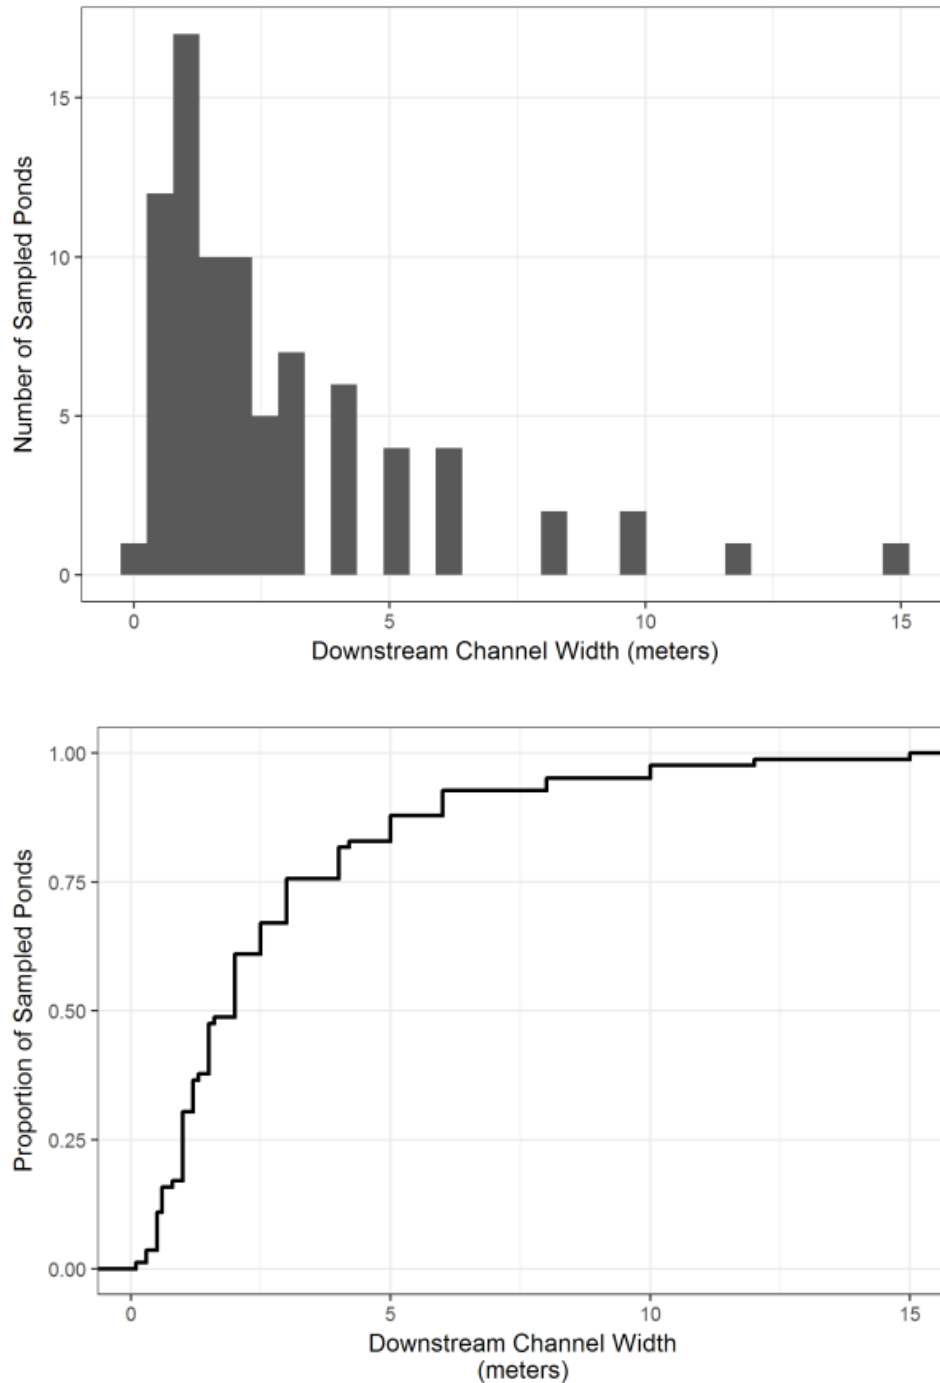
Figure 22. Histogram and CDF of downstream channel width showing that most downstream channels are < 4 m wide.

Of 95 ponds, the majority (87%) had well developed outlet channels, 20 (24%) of which were classified as unstable. As noted above this number compares favorably with the 26% of outlet channels that were both unstable and exposed to livestock use. Downstream bankfull channel widths ranged 0.10m to 15m, while channel depths ranged from 0.08m to 8m (Figure 22 and Figure 23). Over 80% of these outlet channels had bankfull widths greater than 5 m and were 2 m or more in depth which approximates the channel size of many headwater streams in Kansas. Contrast this with the upstream (inflow) channels, which were smaller and with fewer (7%) examples of unstable channel conditions. We believe that pond outlet structures (e.g. trickle tubes, stand pipes, spillways) concentrate the volume and rate of discharge which accelerates the process of stream head cutting and down cutting.

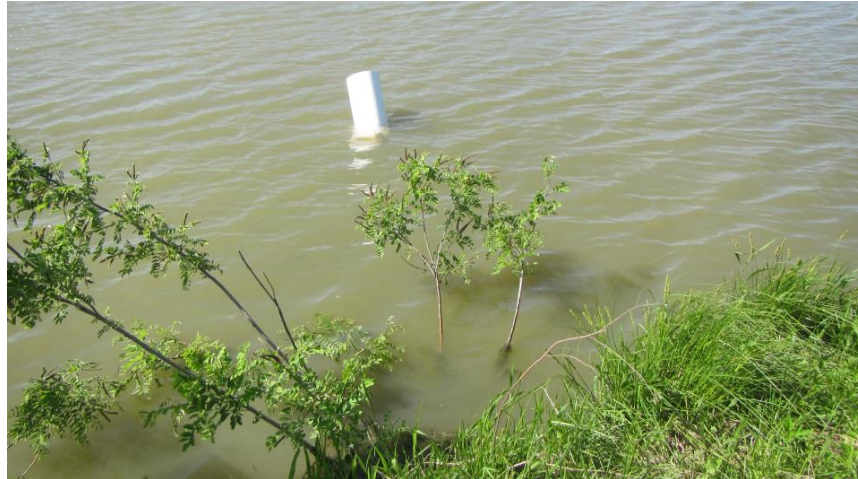
Figure 24. The pond retention area was full and water high into the terrestrial vegetation at pond 179.

The pond retention area was full or nearly full of water for most of the ponds for which this was noted (61 or 75 ponds, Figure 24). As mentioned previously, livestock was present in the pond retention area of 34 ponds.

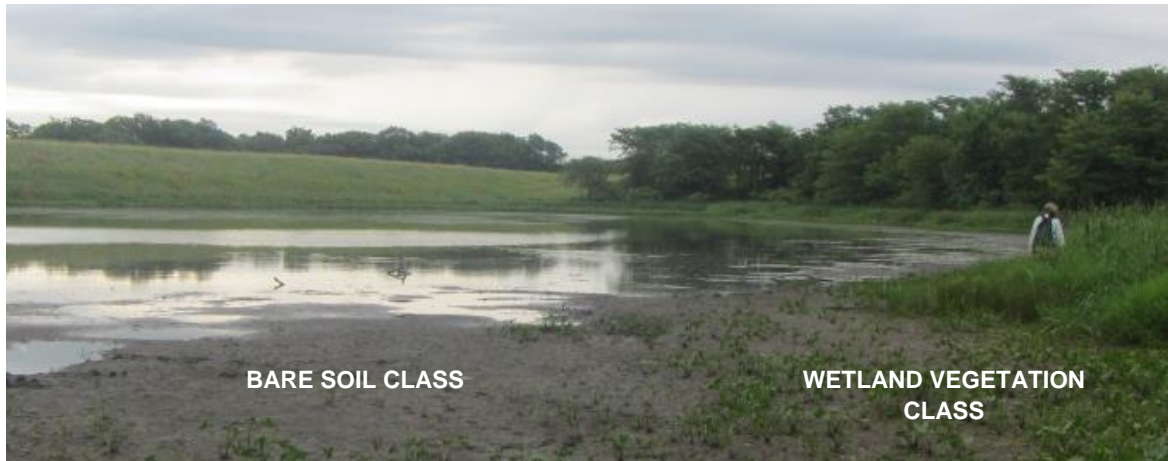
Figure 25. The pond retention area of pond 268 was not full as evidenced by exposed mud flats (i.e. bare soil class), wetland vegetation, and water elevation below bottom of trickle tube.

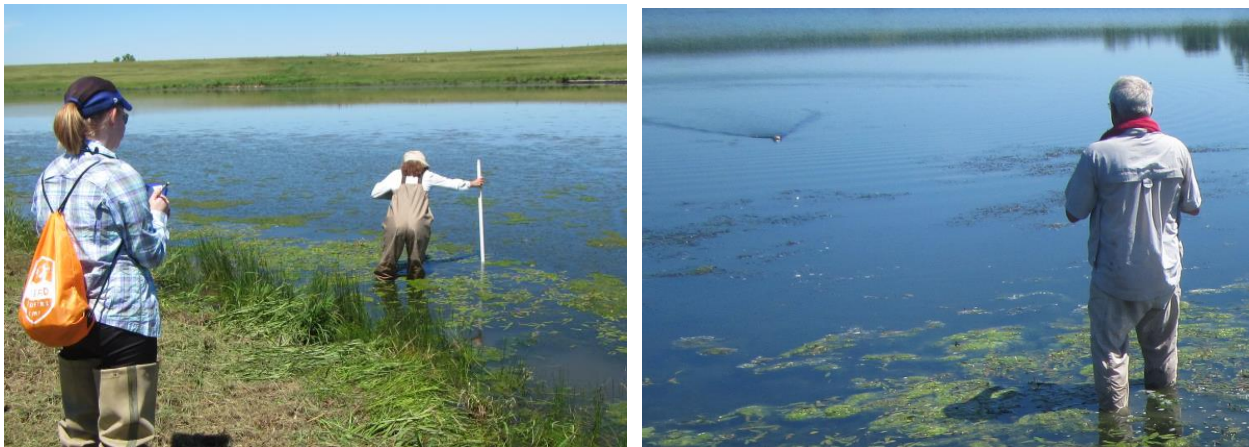
Figure 26. Measuring pond depths around the perimeter with a survey rod (pond 279 left) and remote depth transducer on fishing rod (pond 200 right).

At each pond, five transects were selected and spaced along the dam and the two pond shores originating from the dam. Transect water depths were measured with a survey rod at 1, 2, and 3m from the water's edge (Figure 26). These measurements were considered to be reasonable estimate of the near shore or littoral zone areas of the ponds. Also at these transects three casts of a wireless depth transducer were made with a fishing rod and reel to measure depths at greater distances from shore. The mean cast length was about 16 m (\approx 52 ft) so that depths were typically taken at 16 m then 12 m and a final at about 8 m as the transducer was reeled in along the transect.

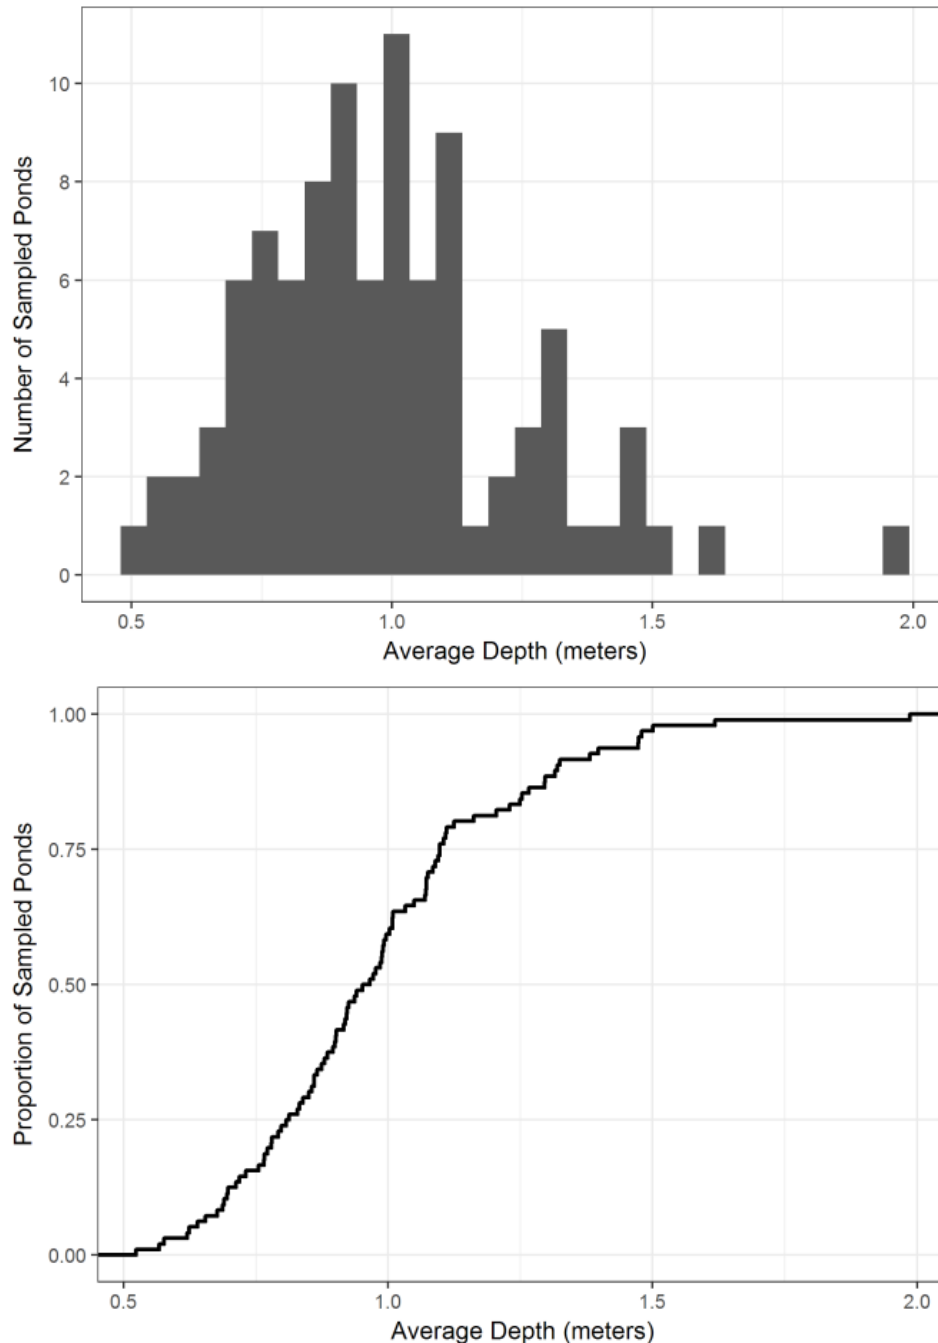
Figure 27. Histogram and CDF of pond depths (up to 16 m from shoreline).

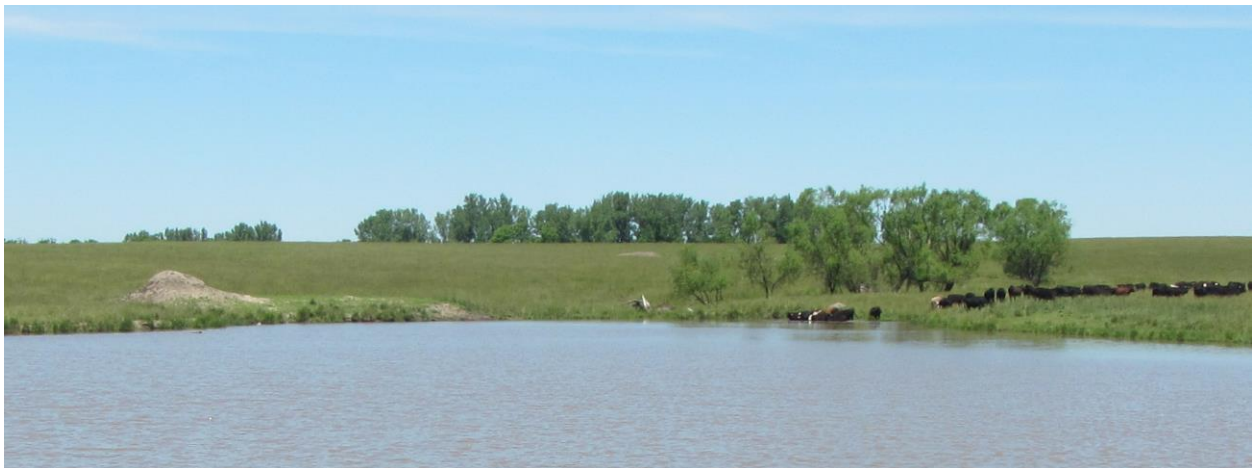
Figure 29. Pond 230 with cattle in the retention area, and a dredging pile (to the left).

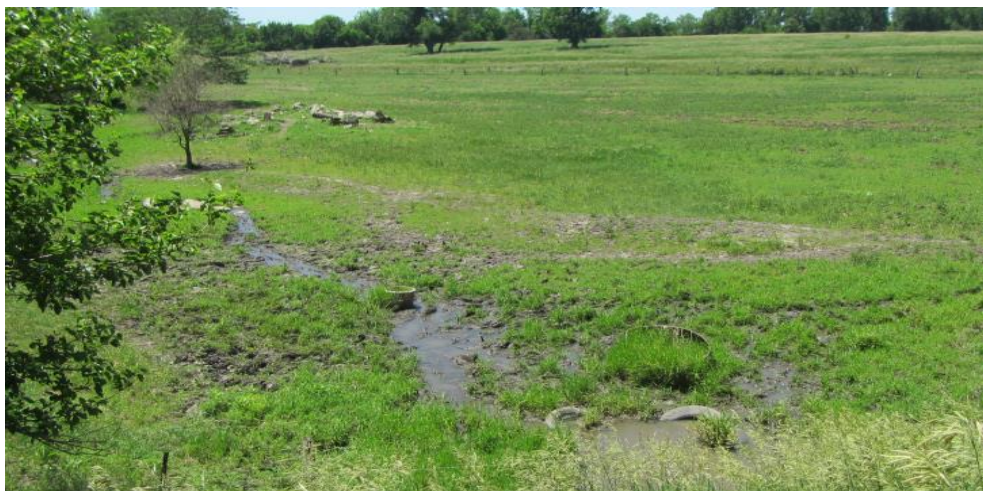
Figure 30. Livestock watering area in the downstream plot of pond 107.

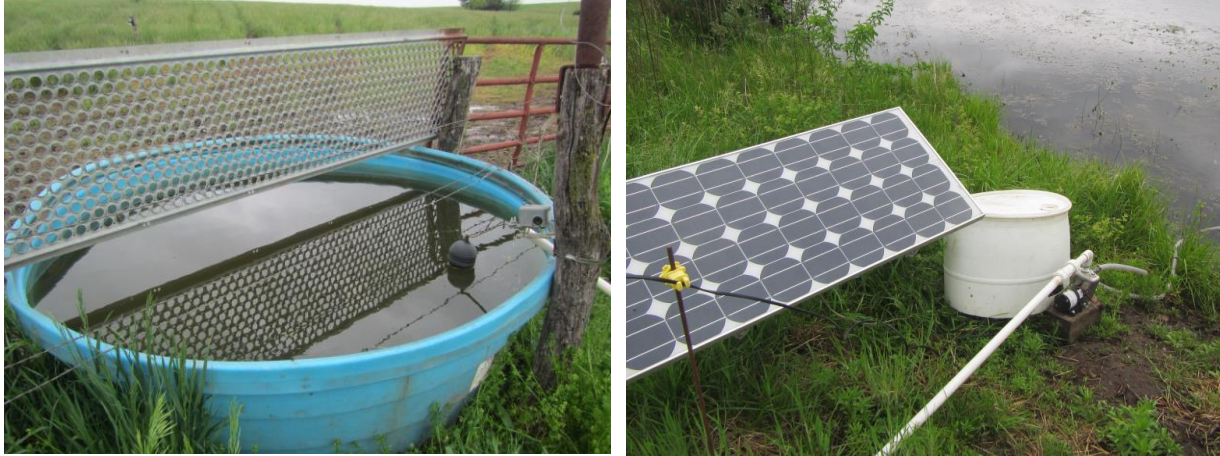
Figure 31. Pond 215 landowner uses best management practices to fence livestock out of pond (left) while a solar-powered pump (right) provides water to the cattle.

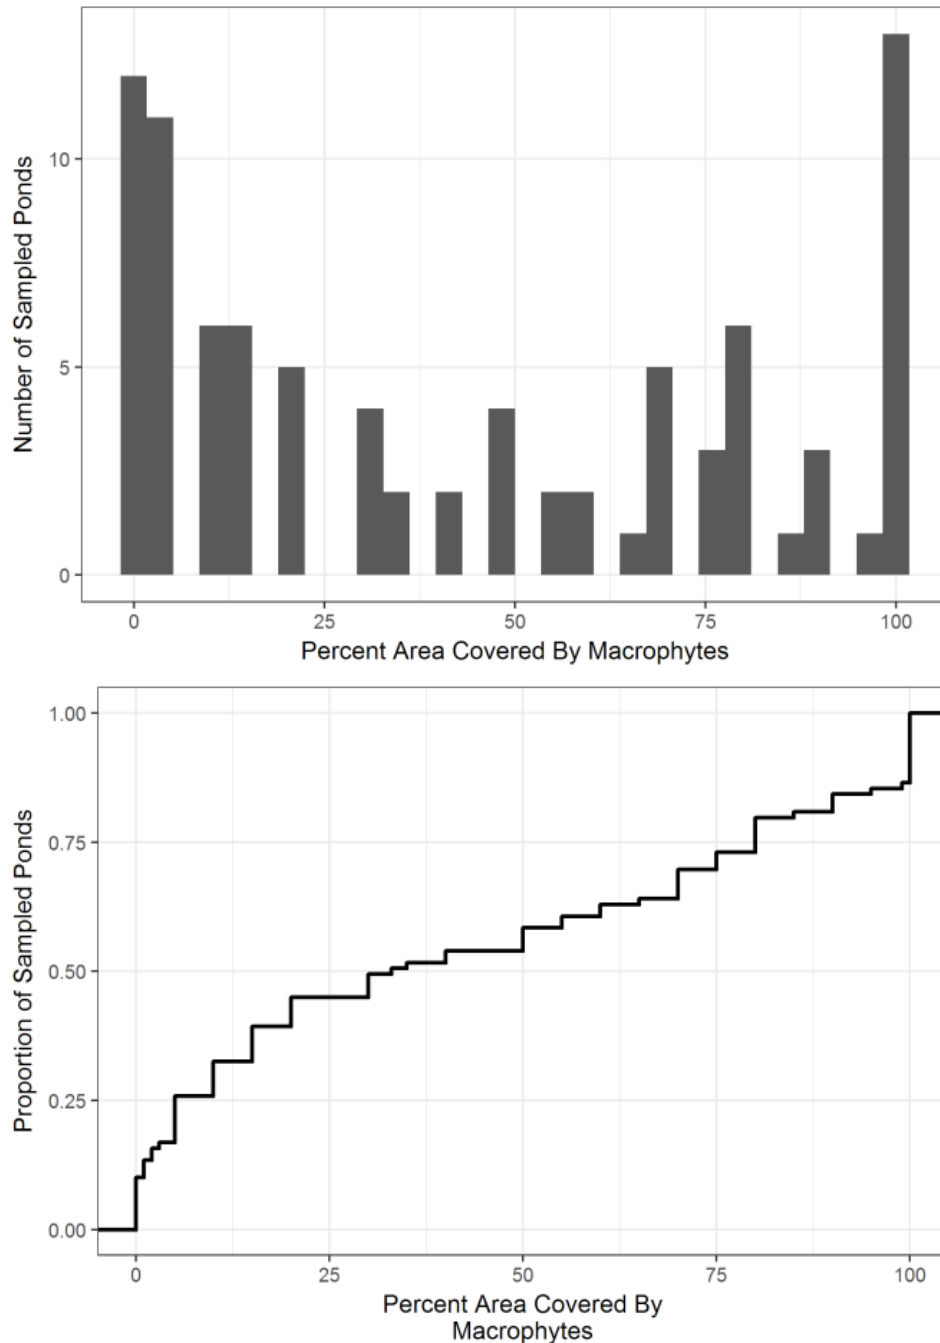
Figure 34. Histogram and CDF of percent shoreline covered by macrophytes.

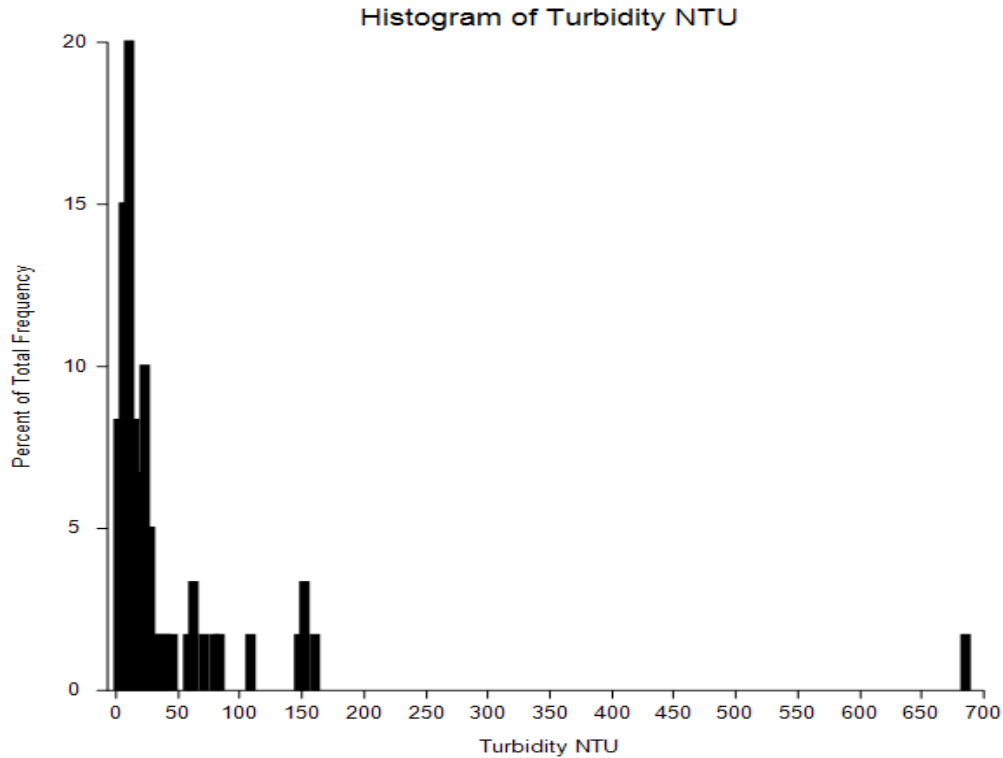
Figure 37. Histogram of individual turbidity values for all ponds.
