Conversion of existing farm ponds to wetlands in agricultural landscapes for mitigation, land use treatment and conservation with a perspective toward climate change.

Kansas Biological Survey Report No. 189

June 2017

**For
Kansas Water Office**

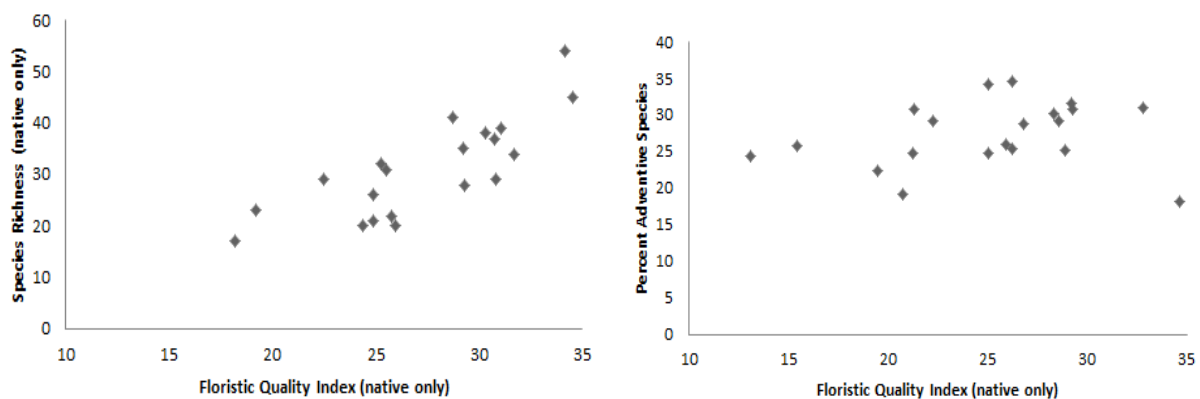
Figure 39. Relationships between floristic quality index (FQI, native only) and species richness (native only, left) or percent adventive species (right).

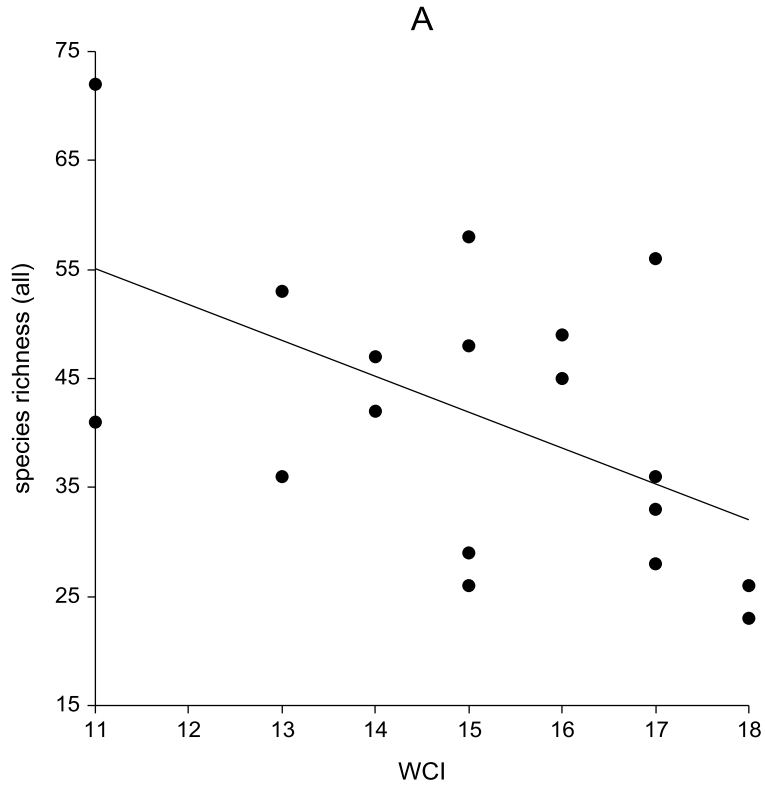
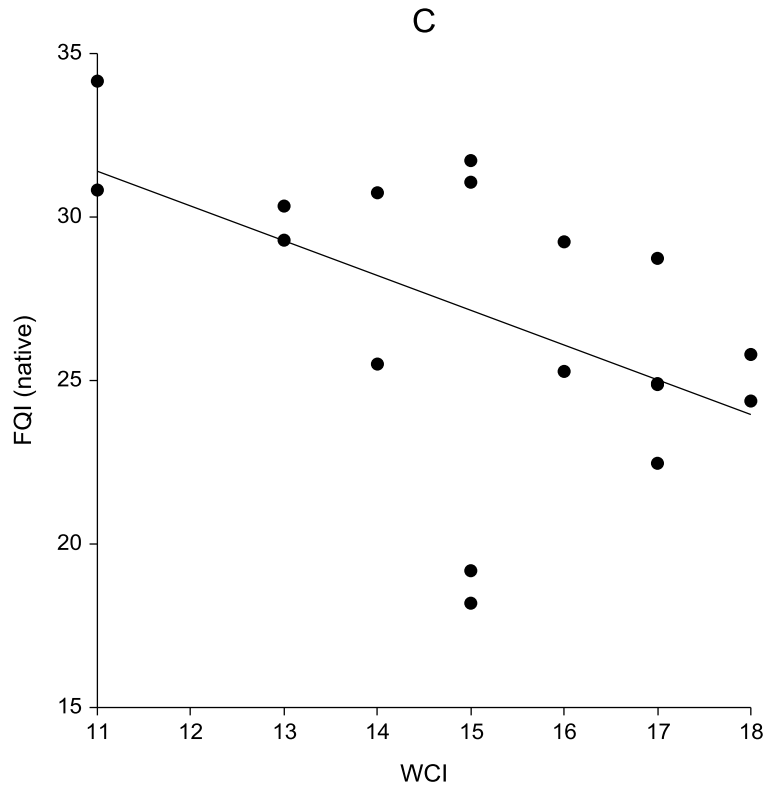
Figure 40. Scatter plots of wetland conversion suitability index (WCI) and vegetation indices for species richness of A. all species and B. only native species; and C. floristic quality index (native species). Linear regression lines are shown. All are significant ($p < 0.05$).

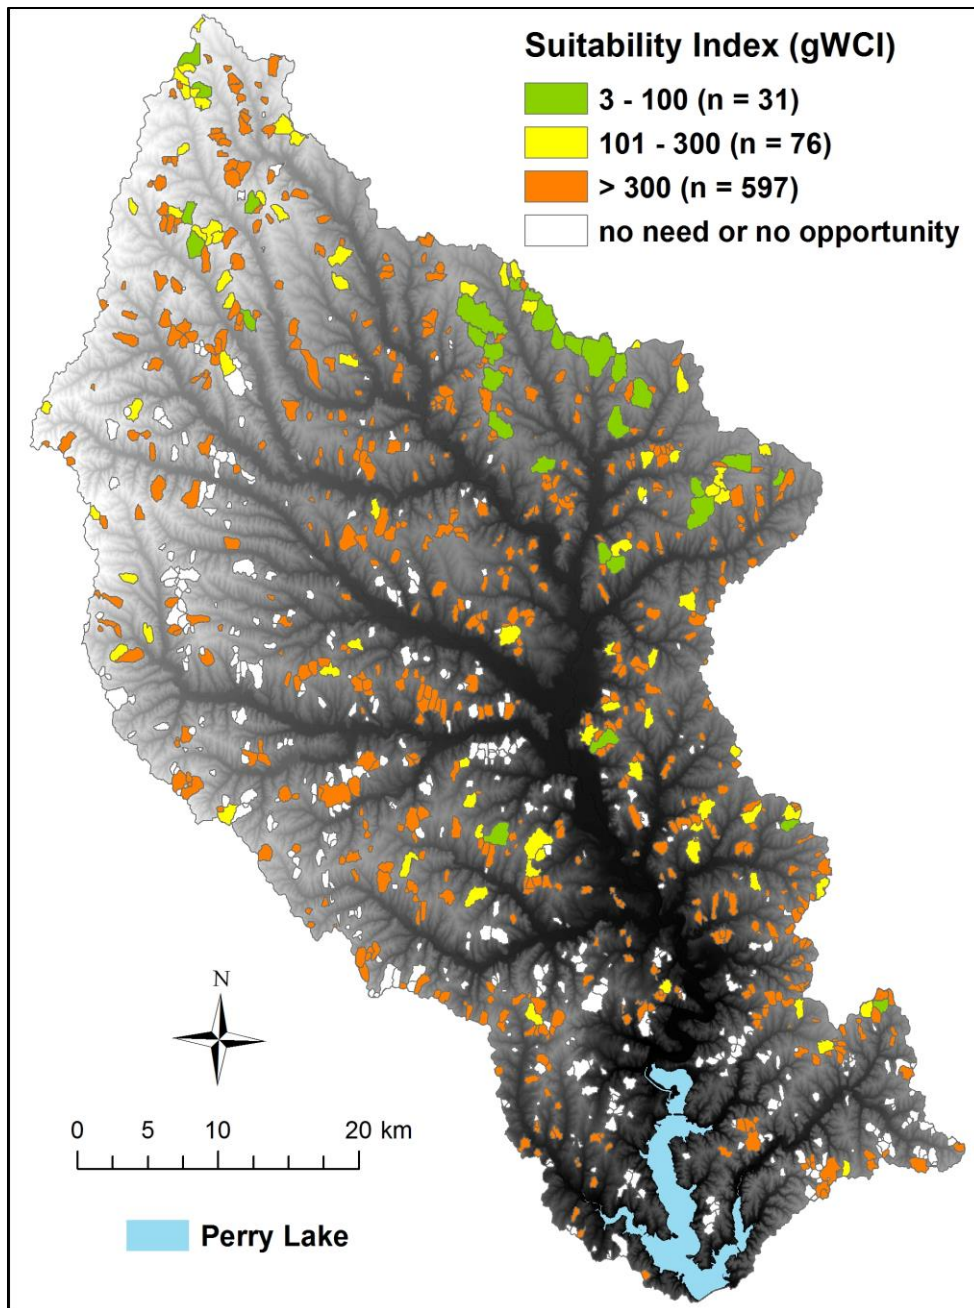
Figure 41. Summarized gWCI rankings for the Delaware River Watershed study area.

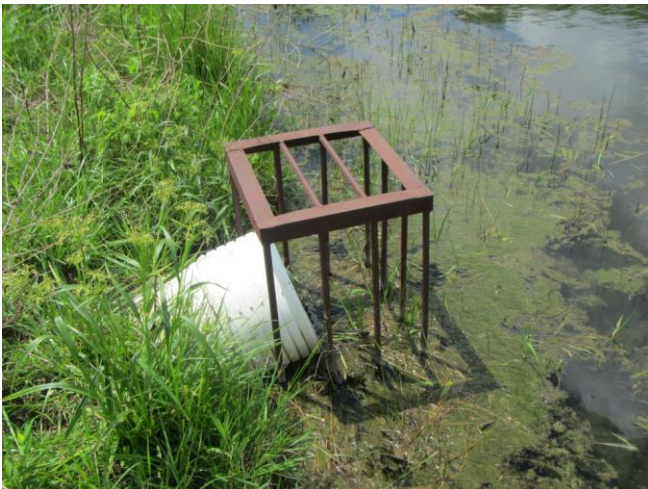
Pond 183 stand pipe. This also shows that the pond retention area was full, but water did not overflow into the terrestrial vegetation.

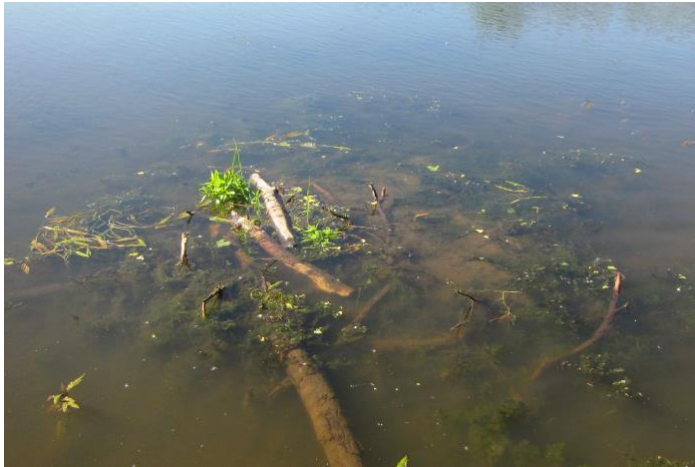
We were not able to locate the stand pipe at pond 223. This might be it, blocked by beavers and sediment.

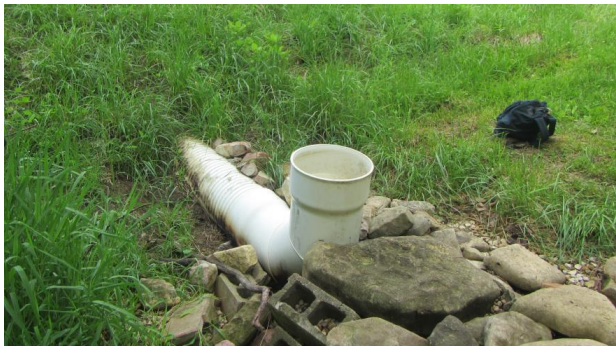
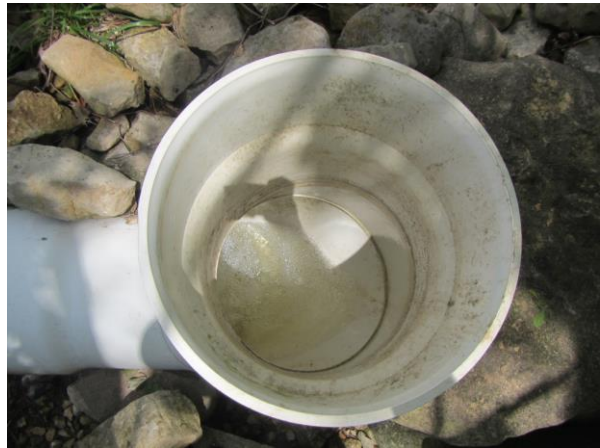
Pond 183 with view (right) inside the pipe showing water that leaks out of a joint in the pipe.

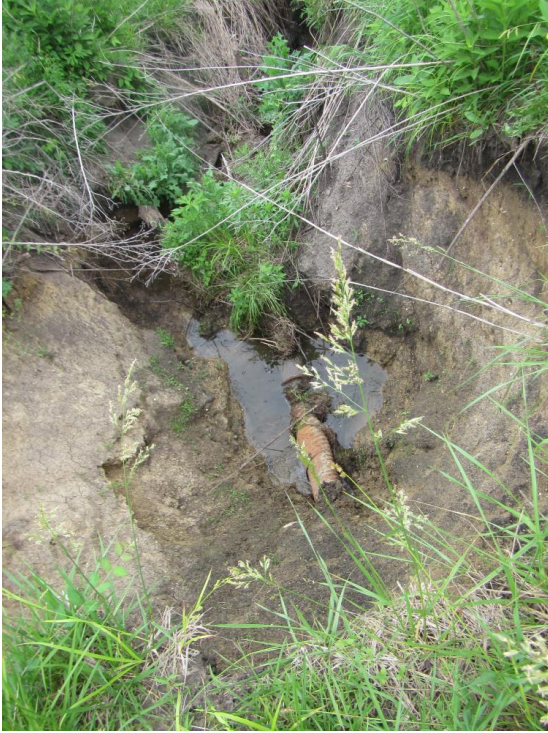
Broken outlet pipe of pond 221, and resulting gully.

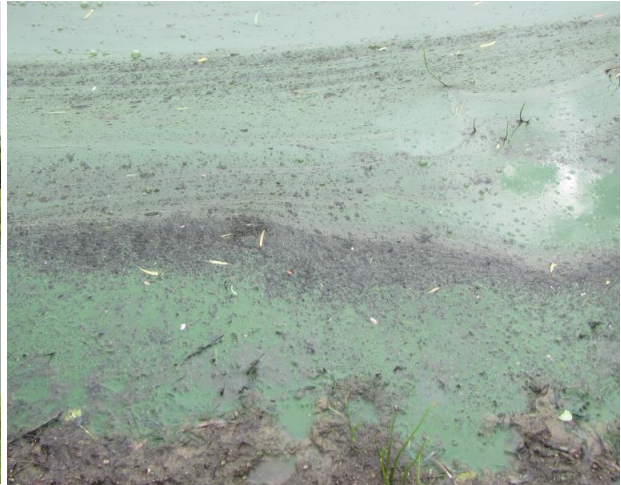
Pond 49 toxic algae bloom?
